Whitfield Bridge Site

Existing Conditions
David Whitfield Bridge

Proposed Condition
David Whittfield Bridge

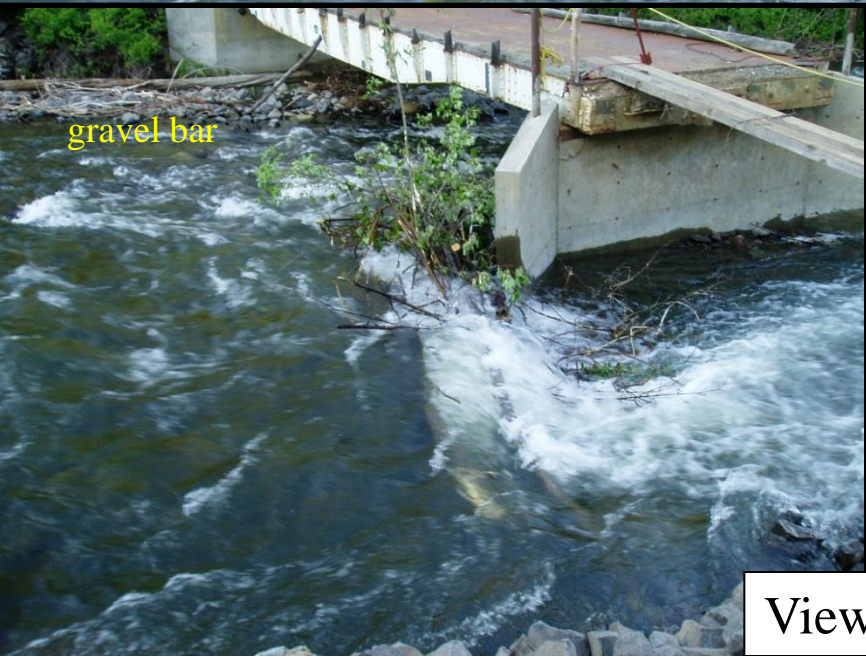
View looking downstream to Whitfield Bridge

Creek washed around bridge end

gravel bar

Eroded Bank

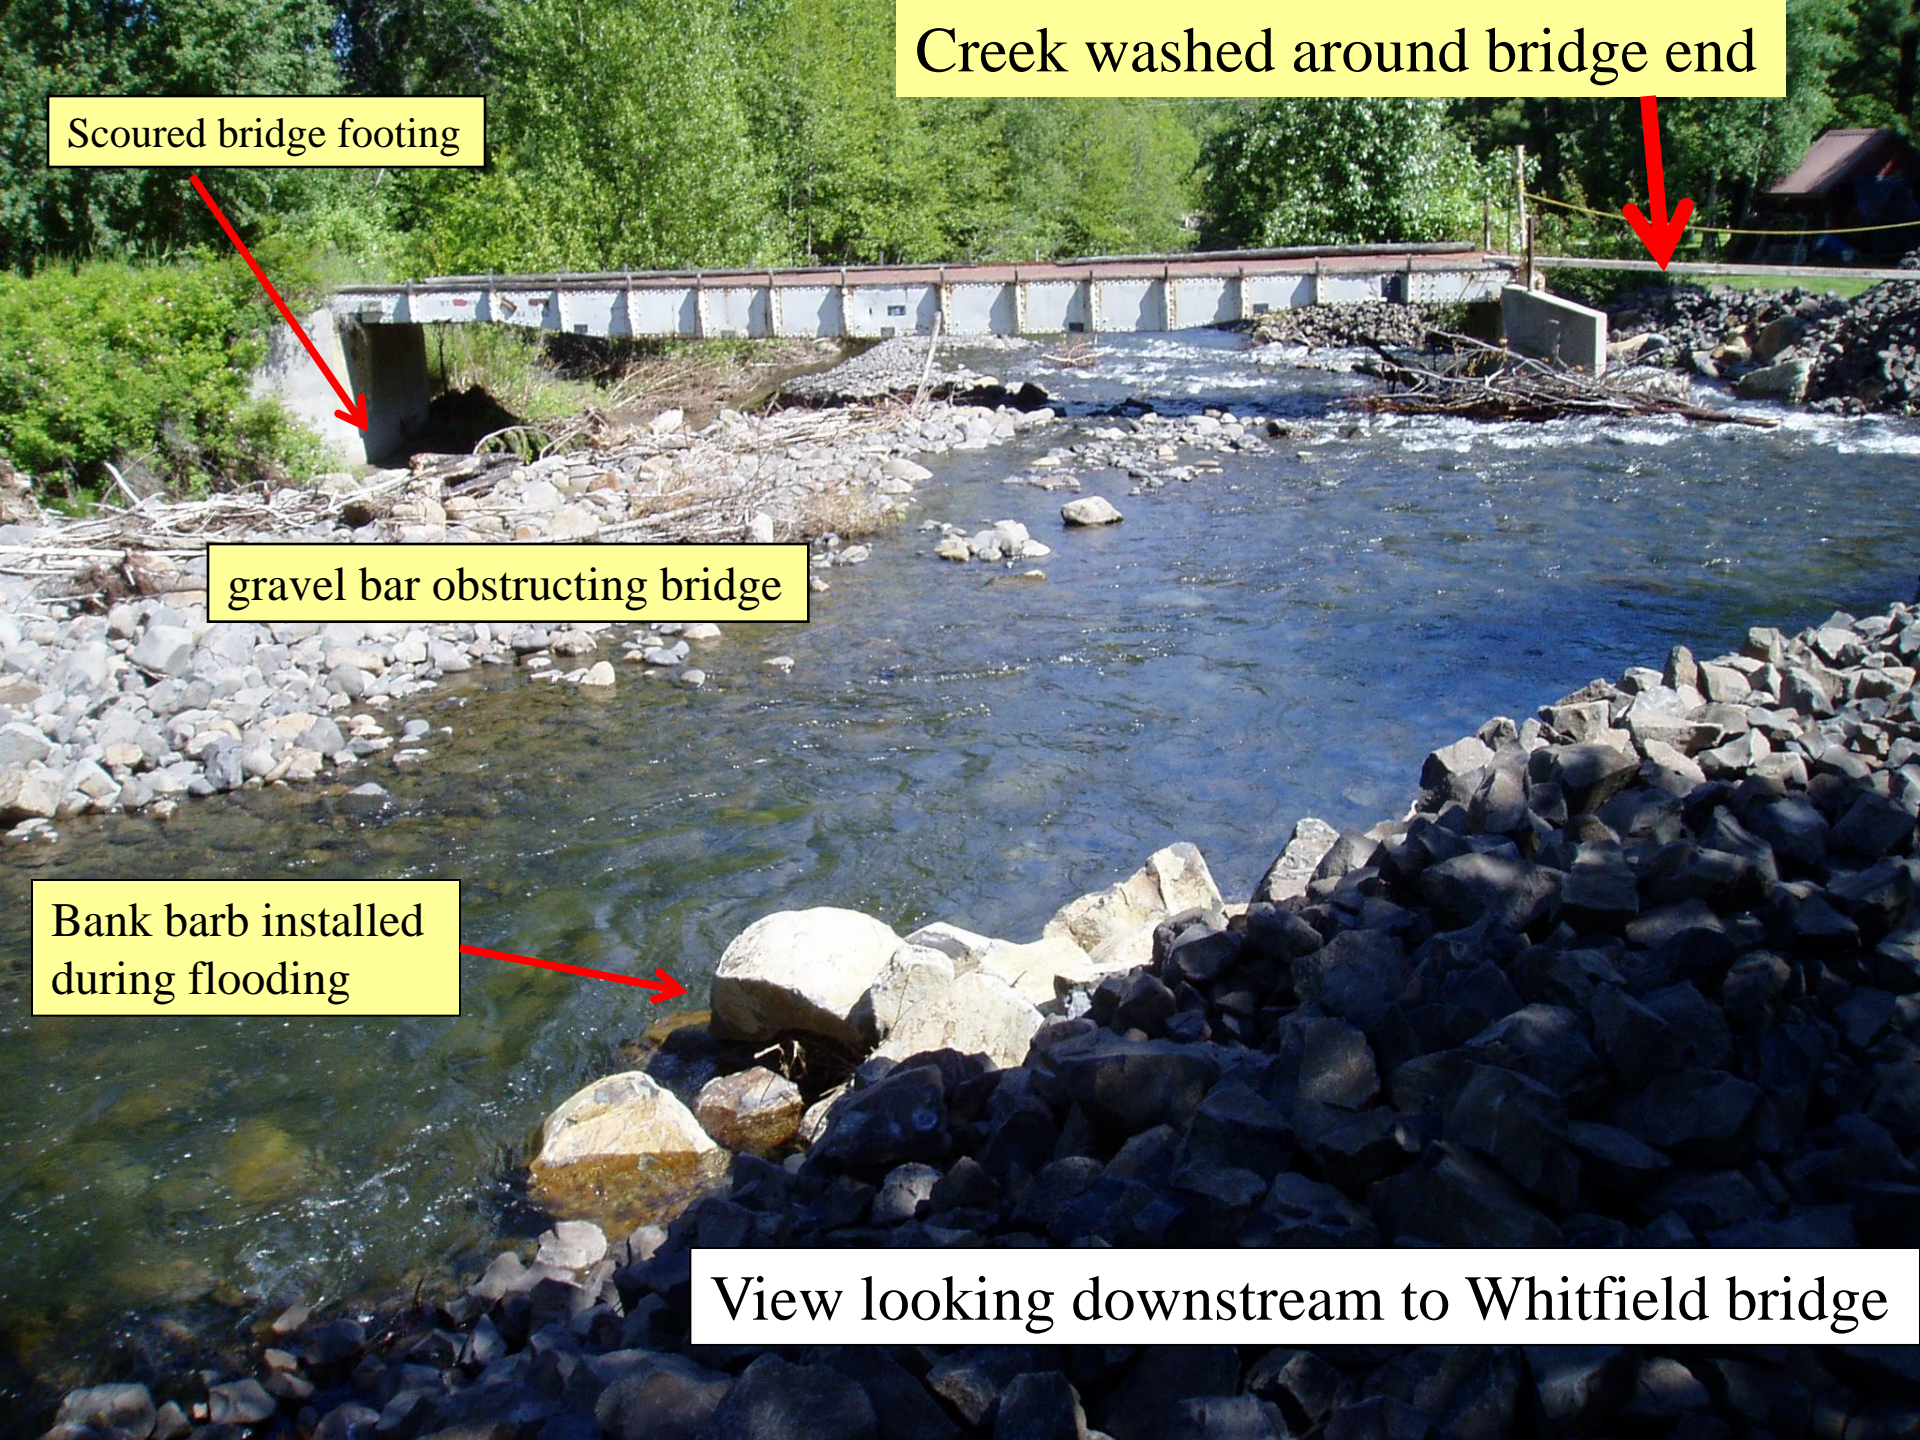
View looking downstream to Whitfield bridge

Creek washed around bridge end

Scoured bridge footing

gravel bar obstructing bridge

Bank barb installed
during flooding

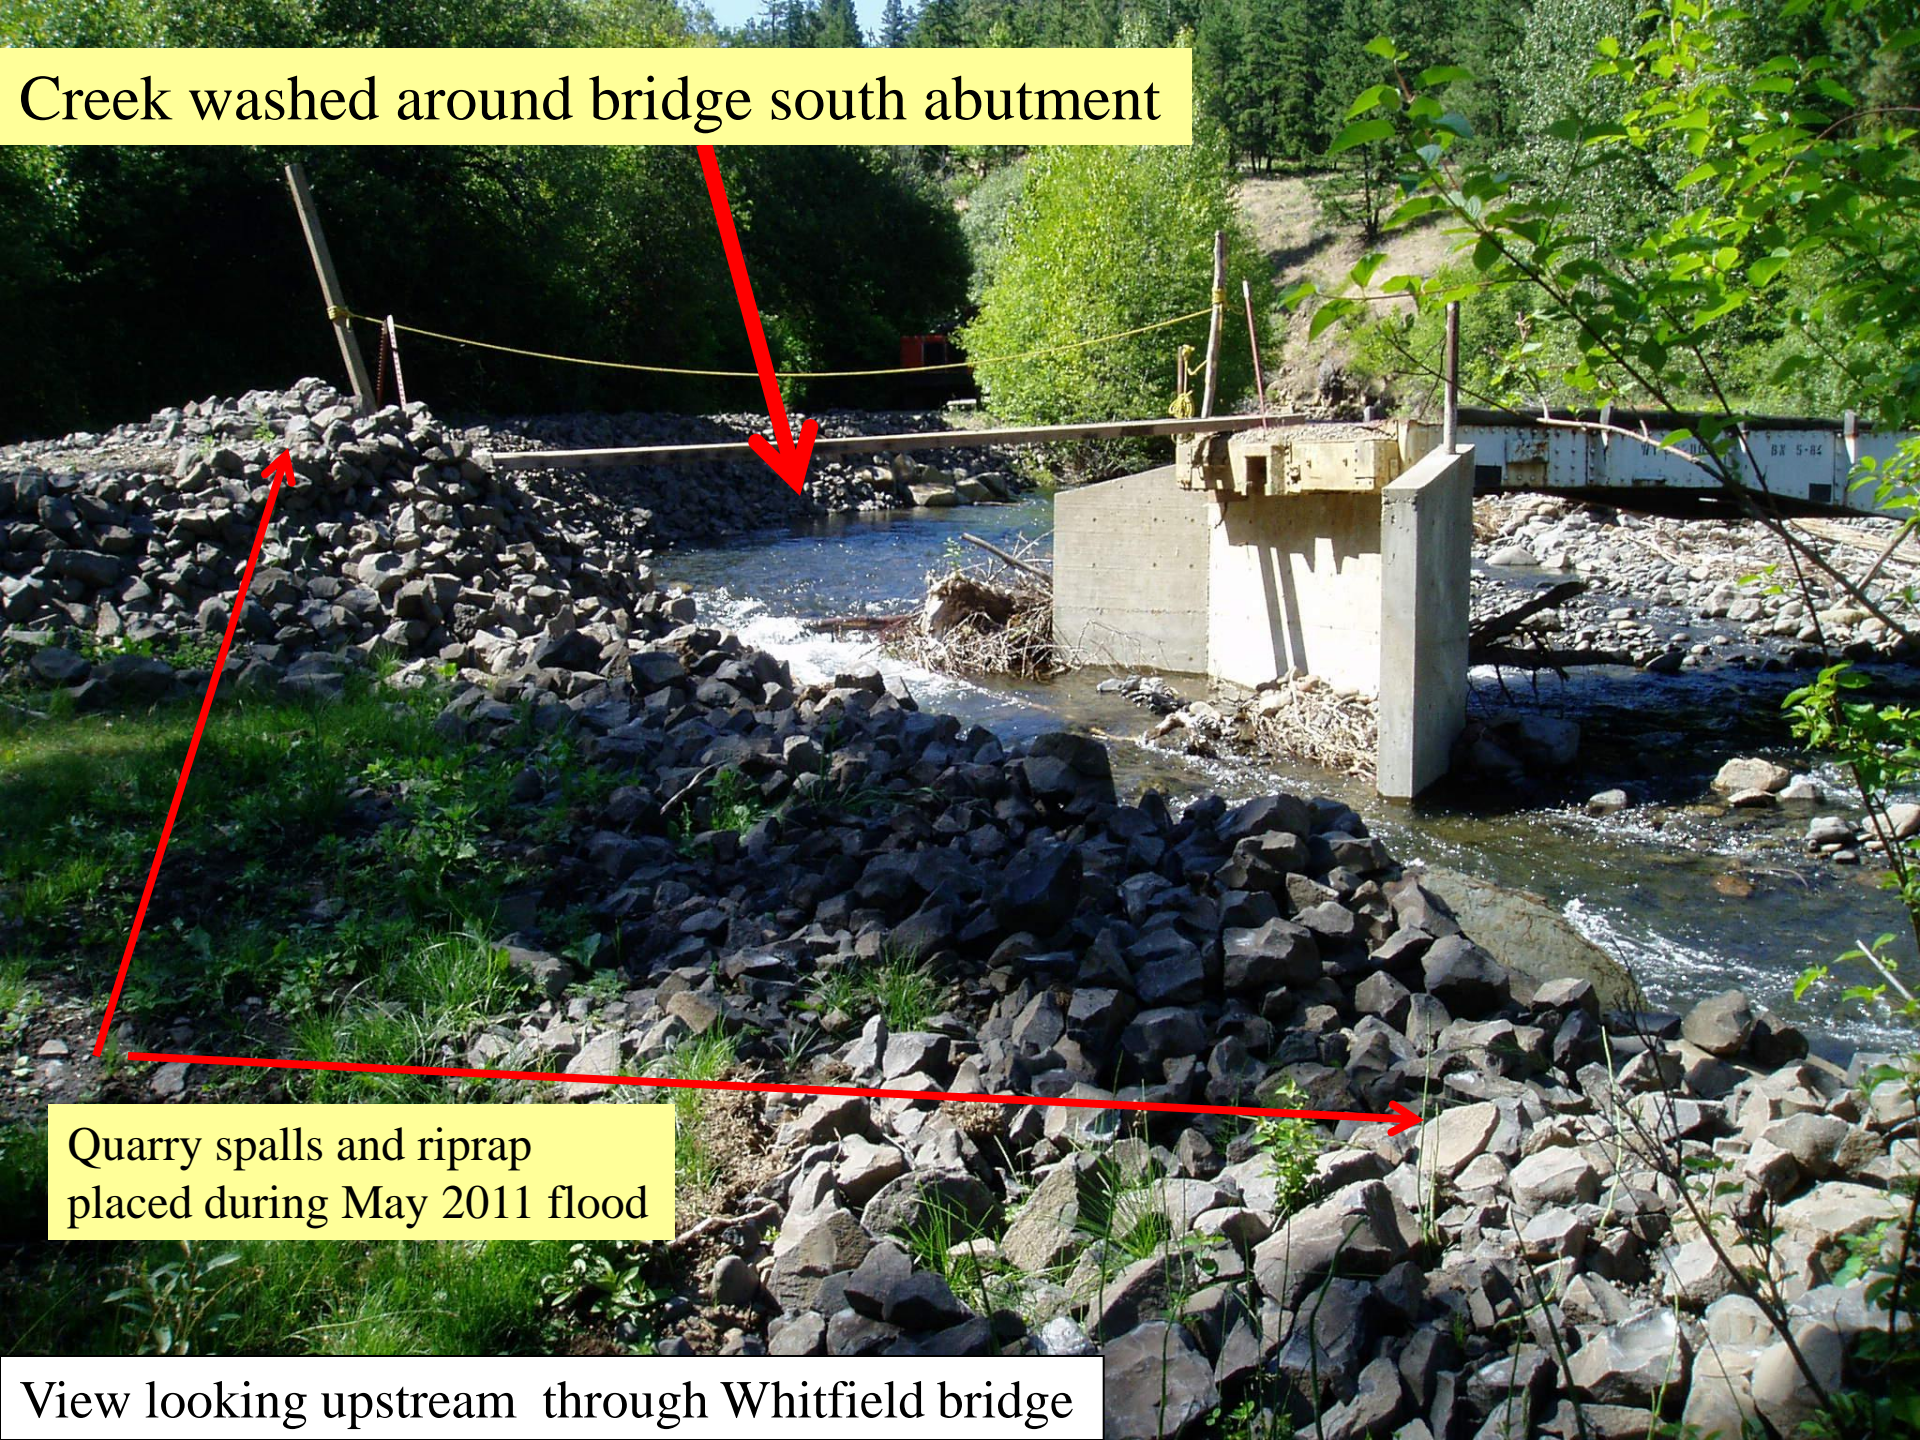
View looking upstream through Whitfield bridge

Creek washed around bridge south abutment

Quarry spalls and riprap
placed during May 2011 flood

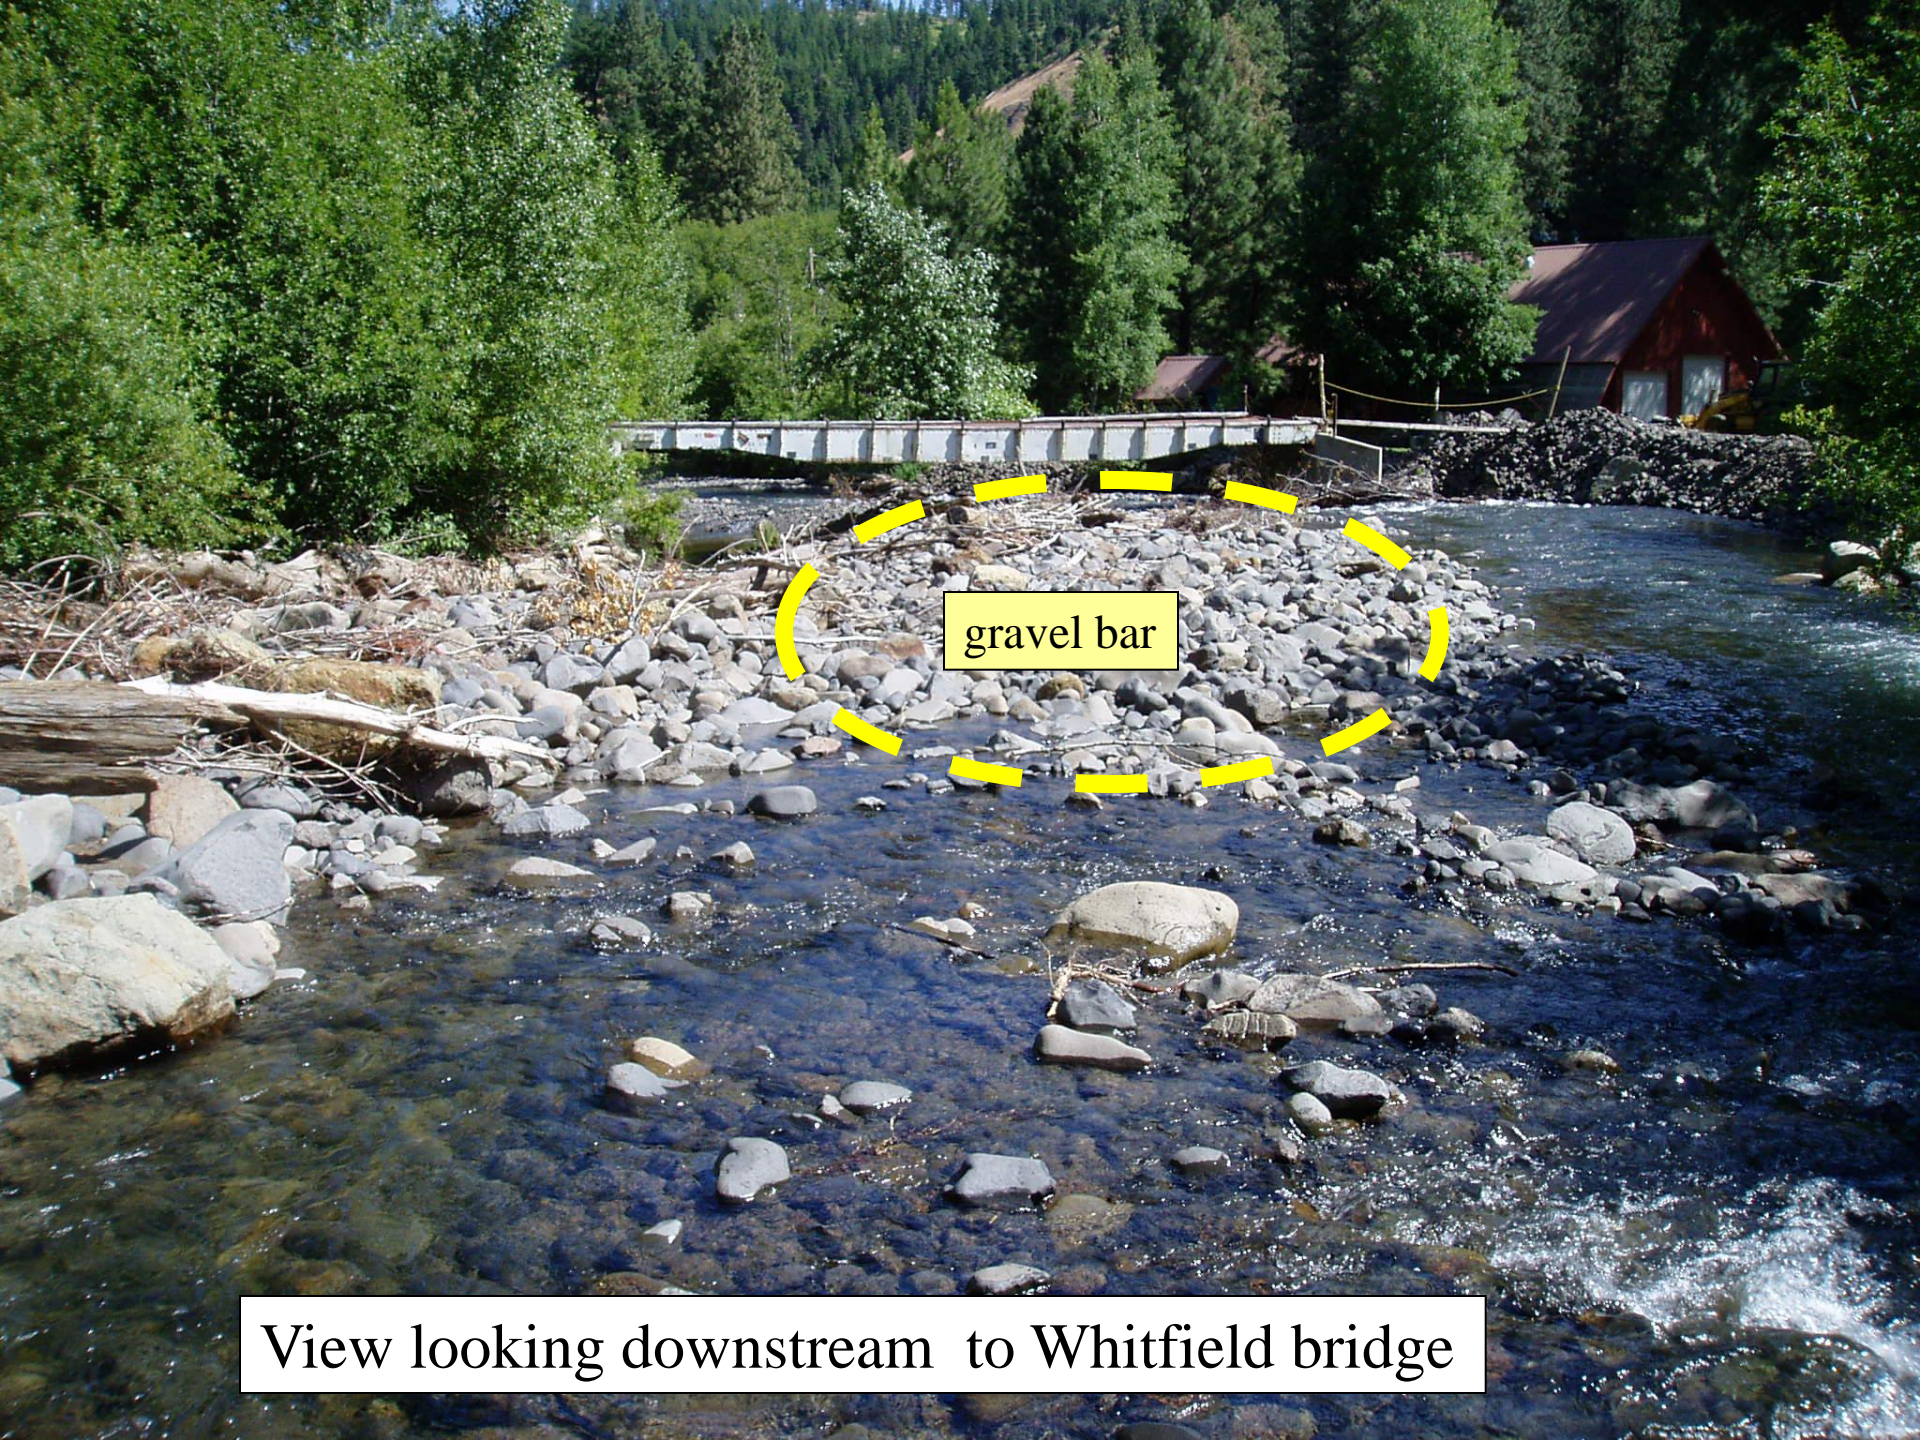
View looking downstream to Whitfield bridge

gravel bar

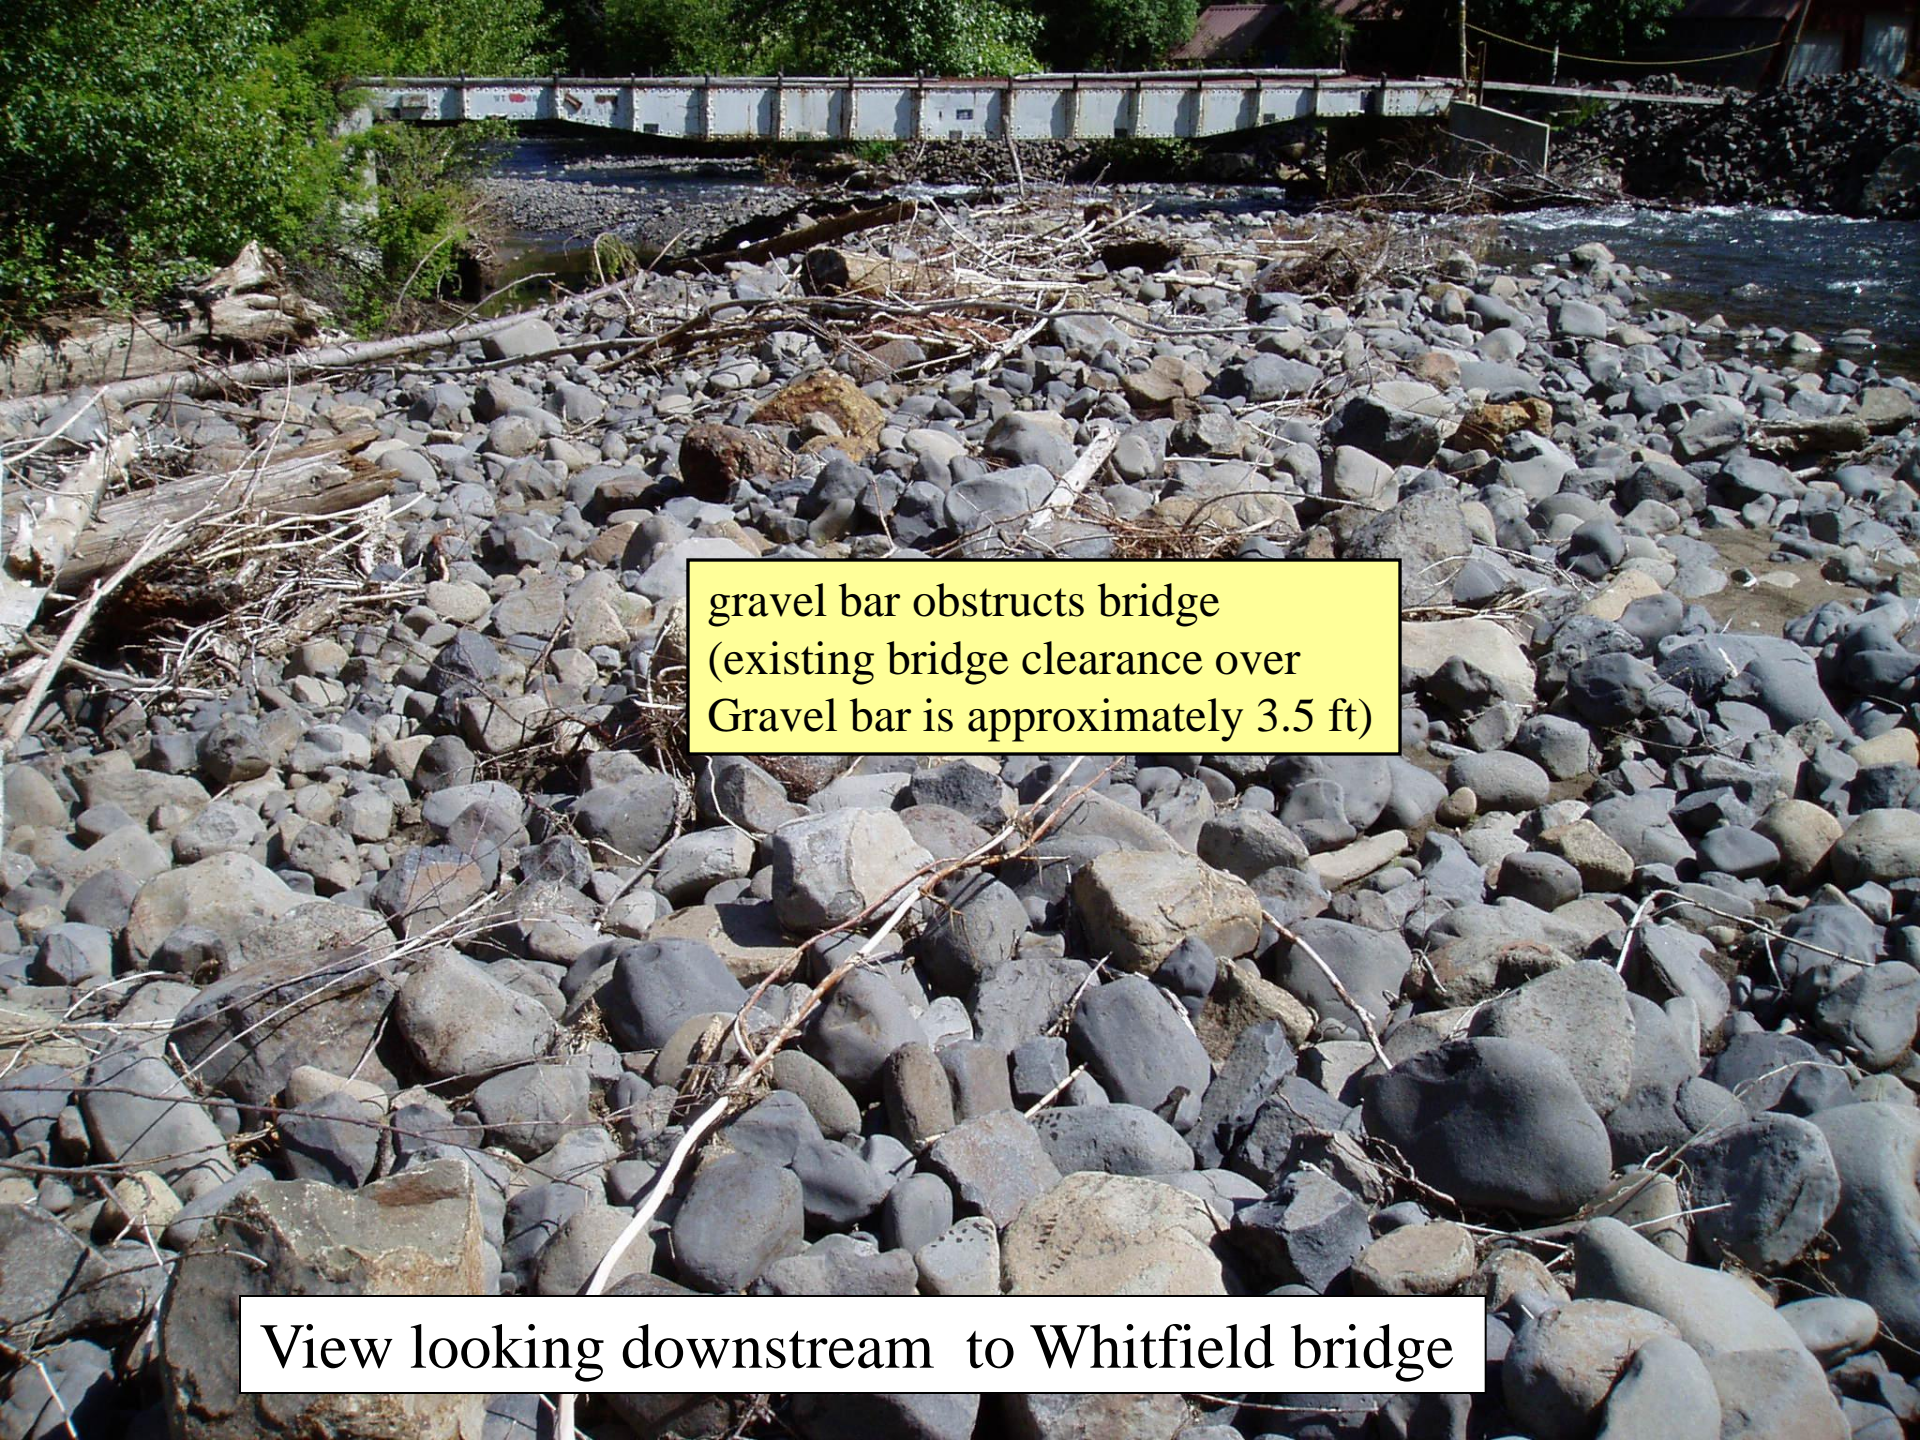
View looking downstream to Whitfield bridge

gravel bar obstructs bridge
(existing bridge clearance over
Gravel bar is approximately 3.5 ft)

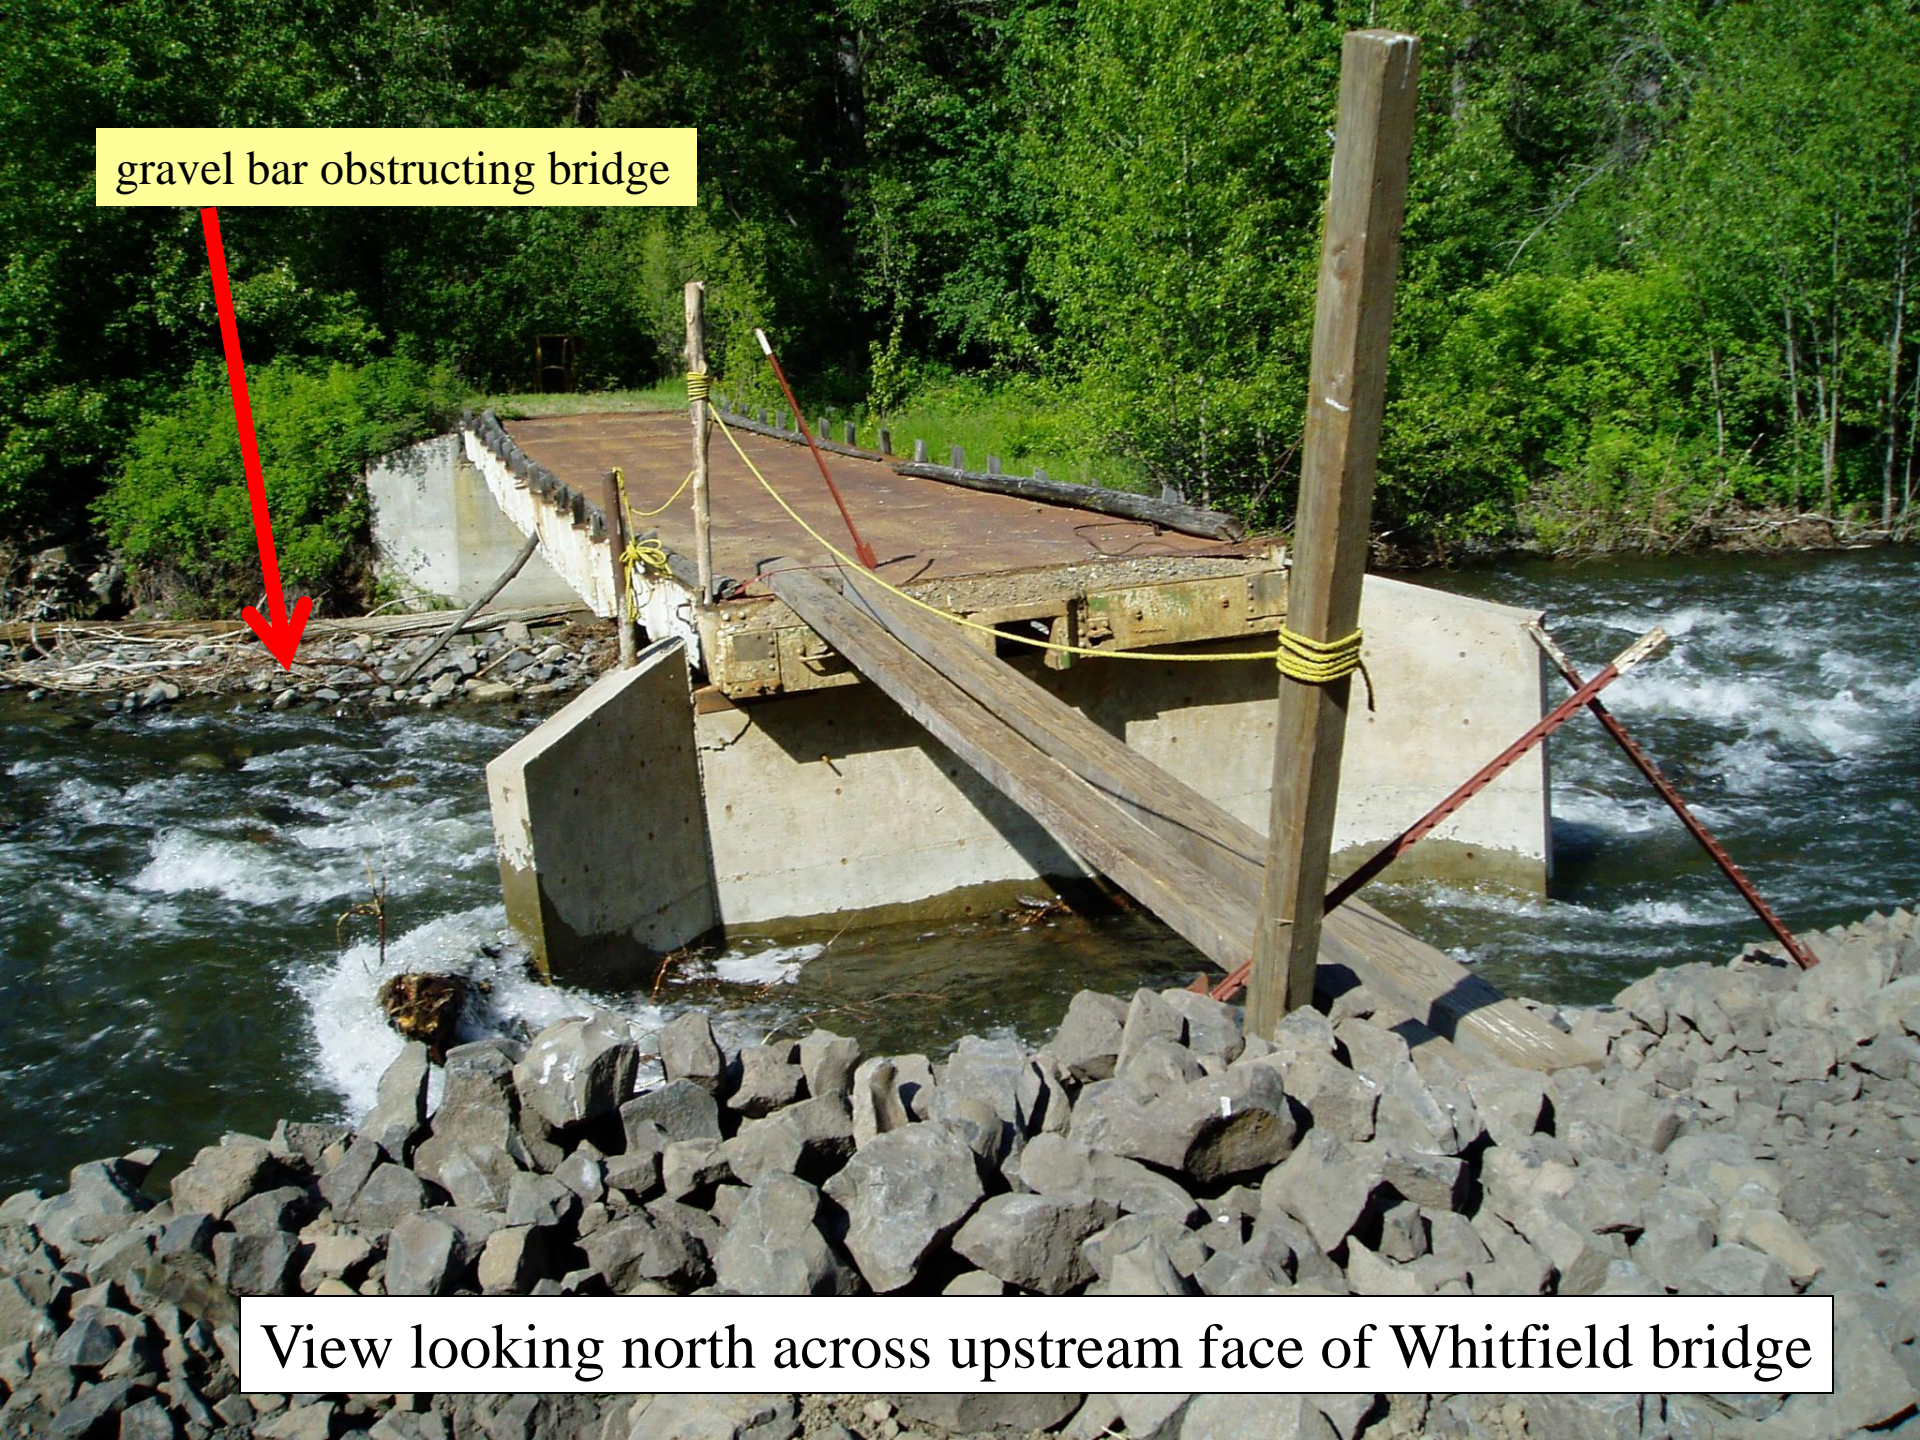
View looking north across upstream face of Whitfield bridge

gravel bar obstructing bridge

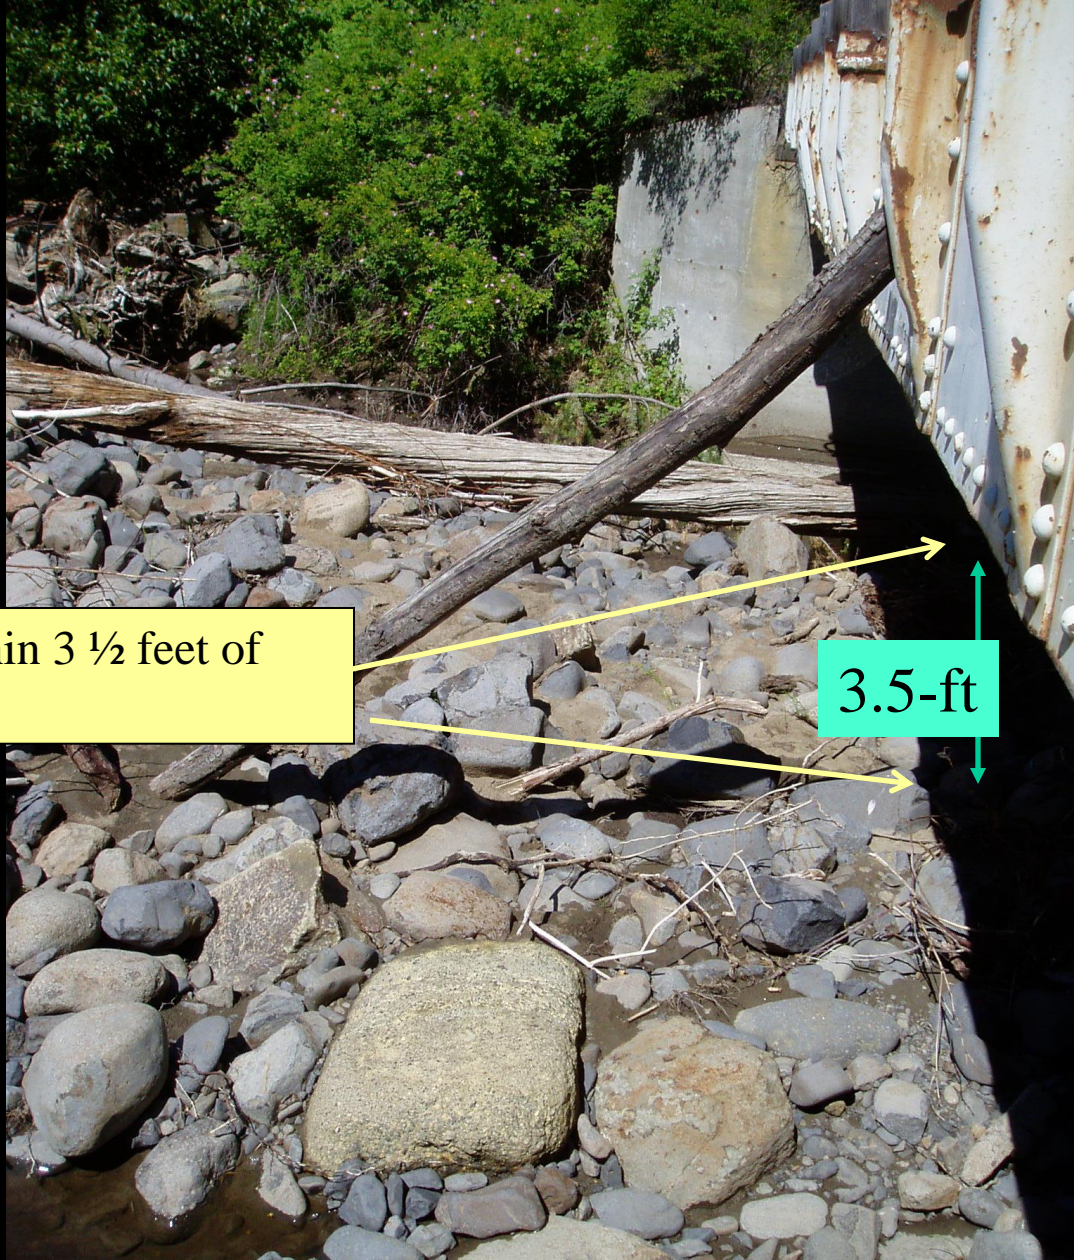
View looking north across gravel bar at upstream face of Whitfield bridge

Gravel bar to within 3 1/2 feet of bridge beams

3.5-ft

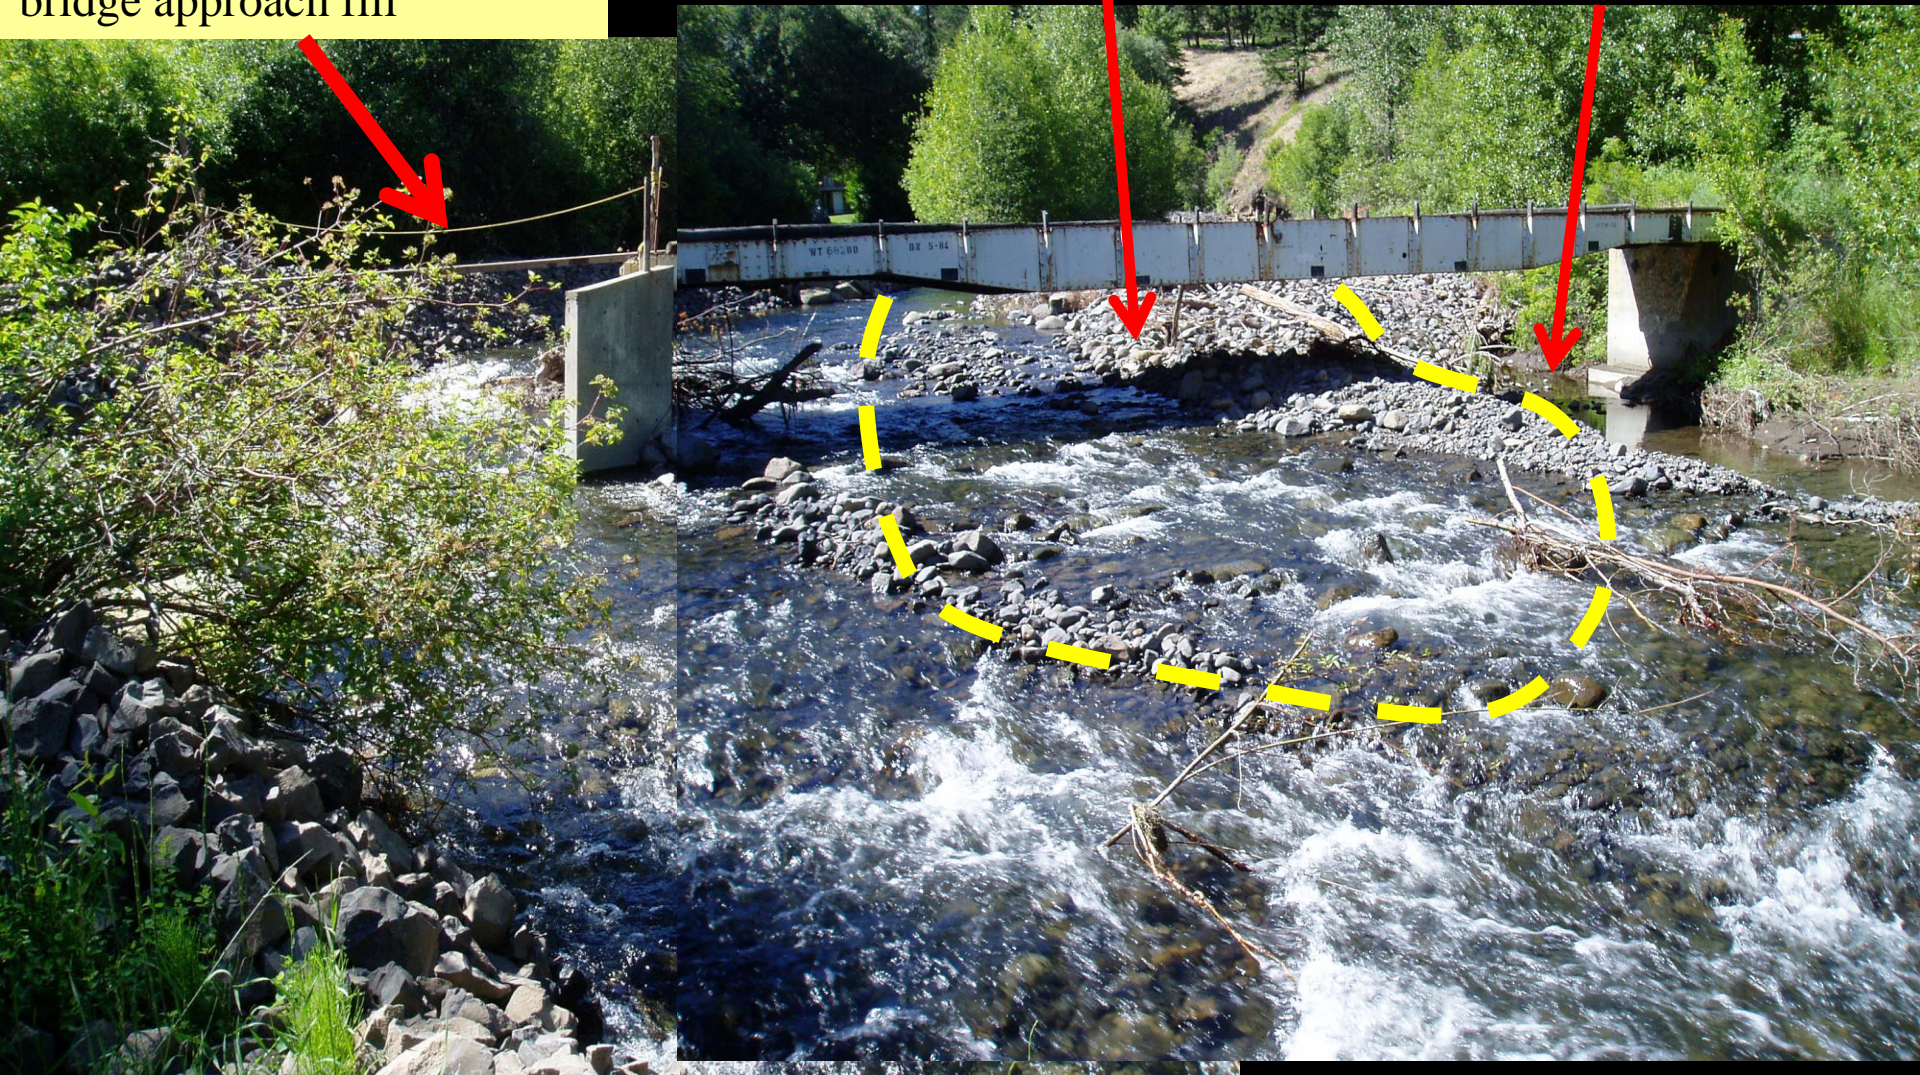
View looking upstream through Whitfield bridge

Creek washed around bridge.
Reconstruct bank and replace
bridge approach fill

Remove gravel bar

Fill scour hole

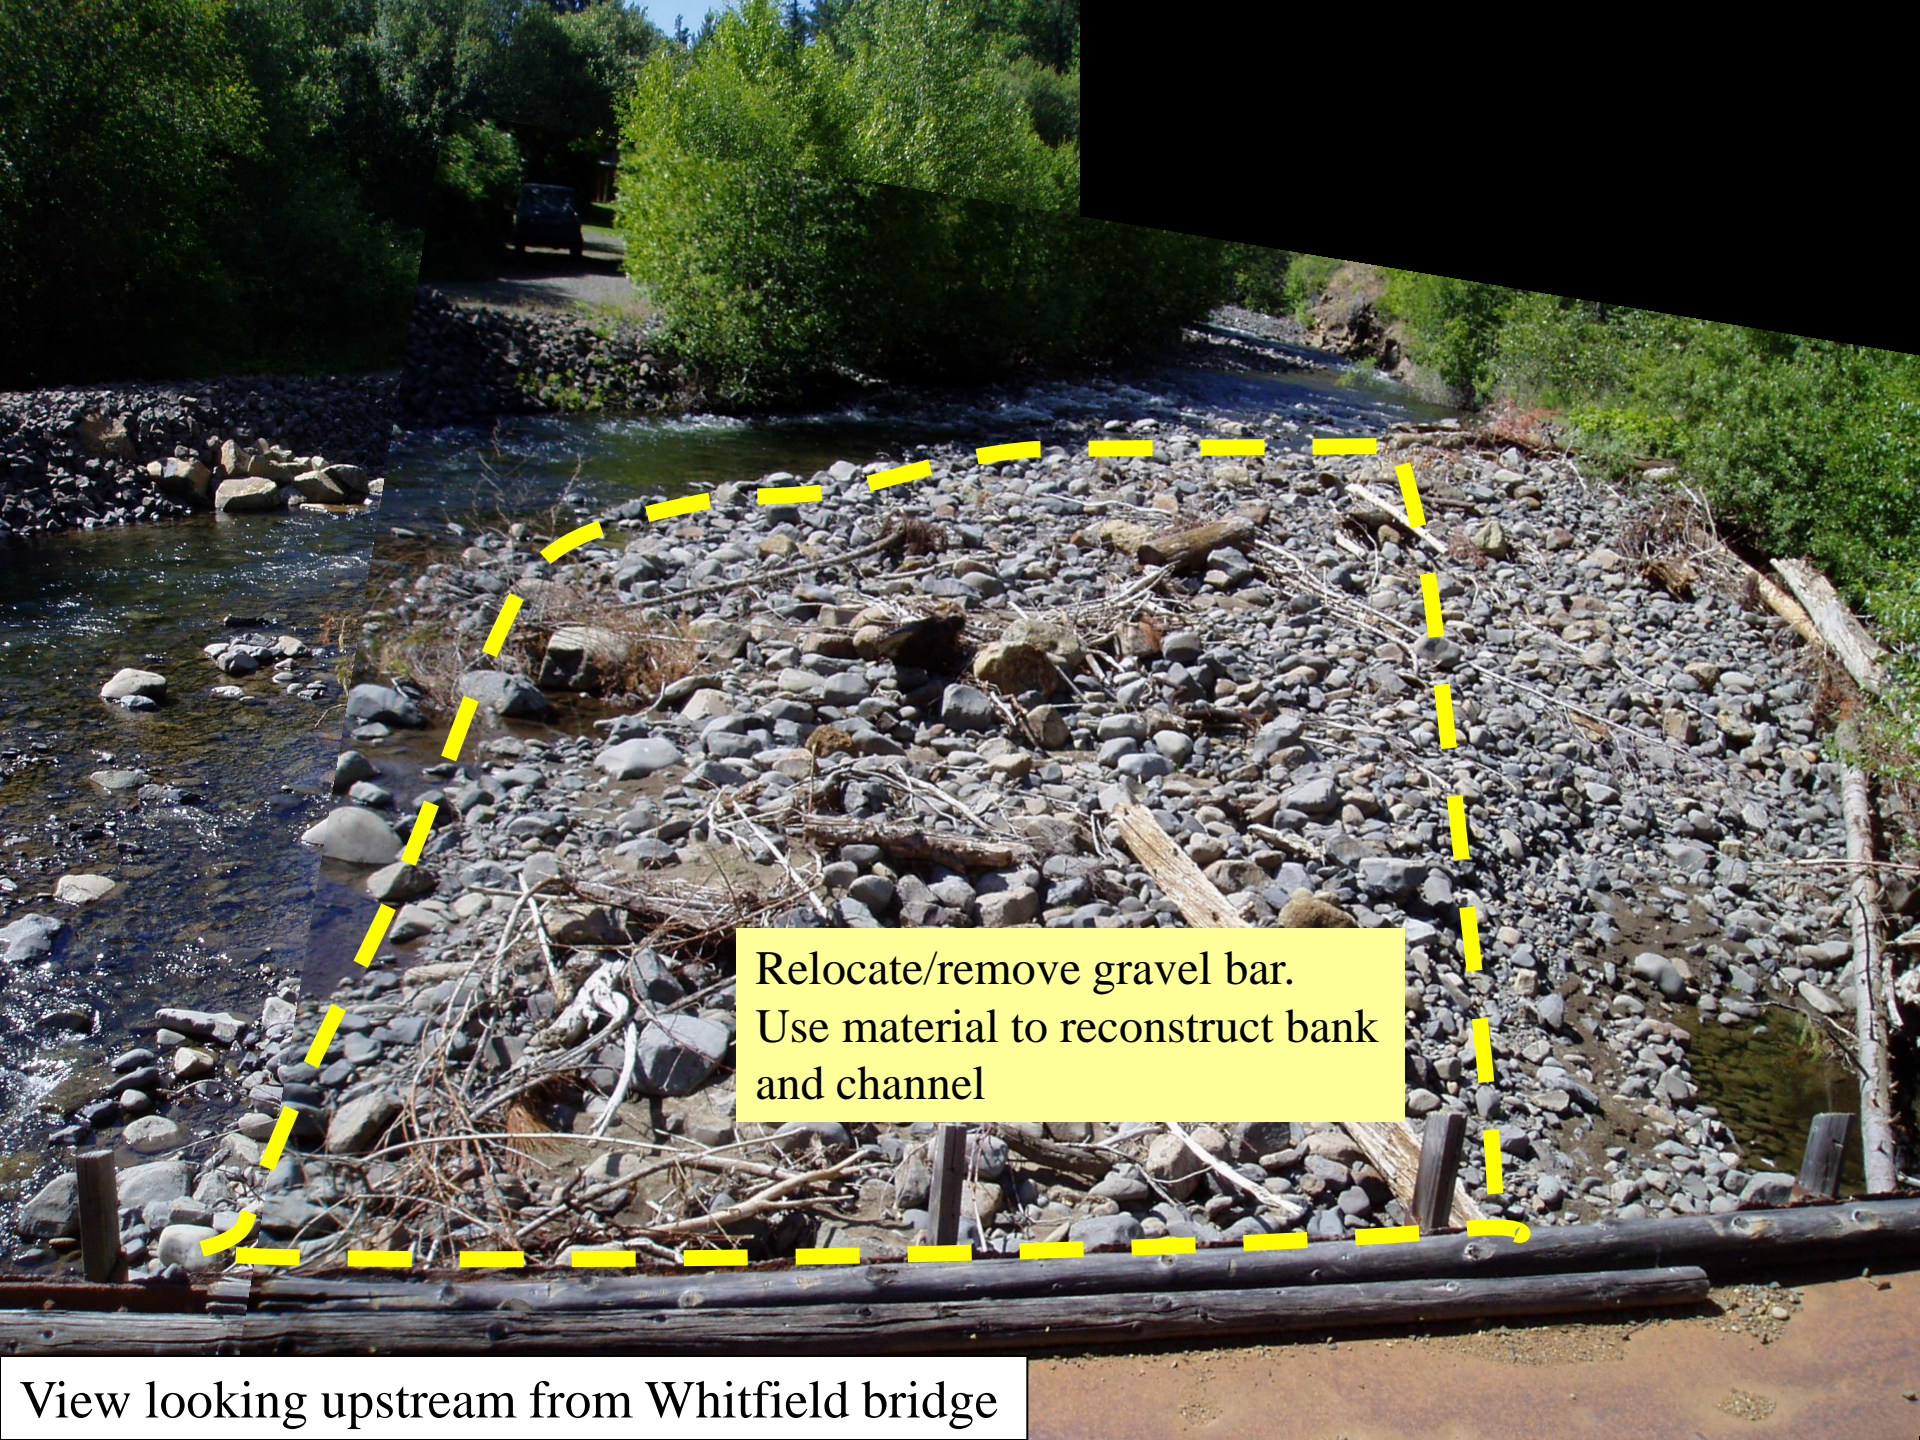
View looking upstream from Whitfield bridge

gravel bar obstructs bridge

Relocate/remove gravel bar.
Use material to reconstruct bank
and channel
